Arctic museum and Exhibition Center

**Report on the expedition to Franz Josef Land
with the aim of restoration of the hangar for
the aircraft on the polar station "Bukhta
Tikhaya" 05.07.2018 – 24.08.2018**

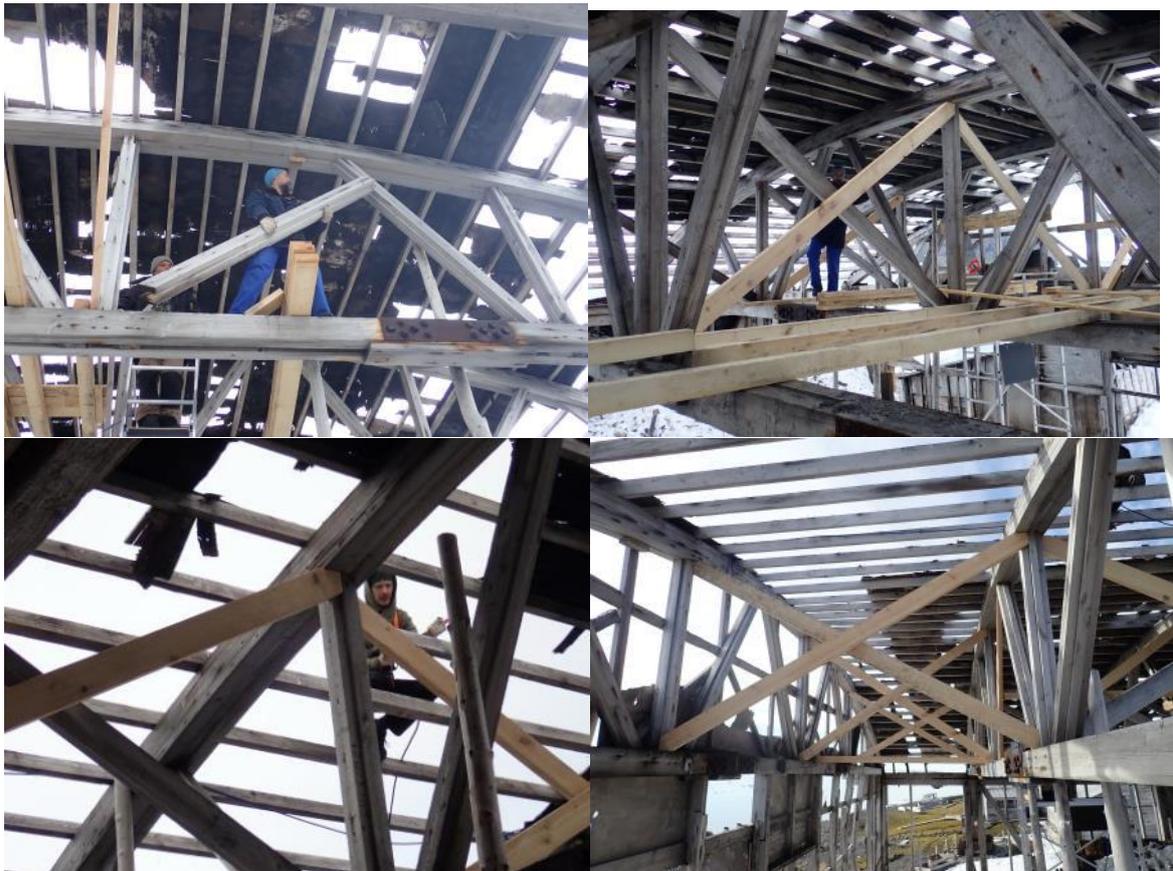
Figure 13. Installation of bows

July 18, we organize our life and in parallel we begin systematic work on the hangar, having equipped a workshop in the Aerological pavilion near the hangar. Architects-restorers immediately engaged in the manufacture and installation of missing longitudinal braces between truss farms.

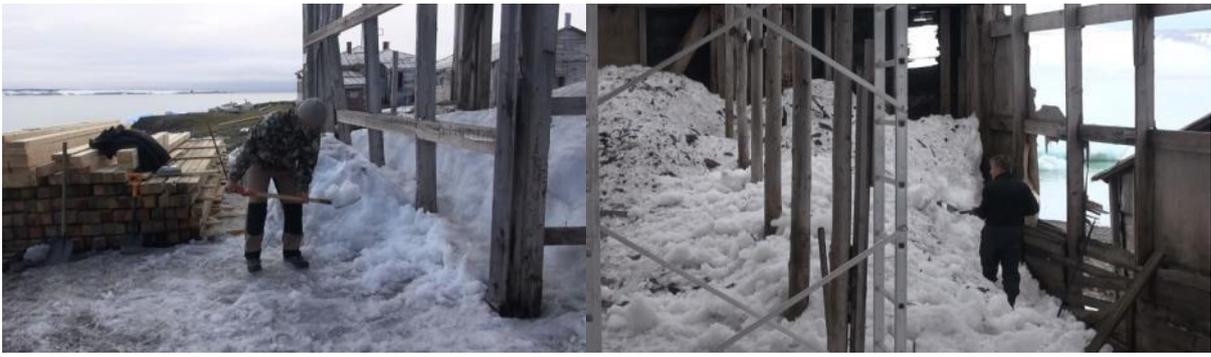
Figure 14. Clear from snow.

The rest were busy clearing the entrance to the hangar from the snow. As of July 18, the entire front facade of the hangar was completely covered with a snowdrift.

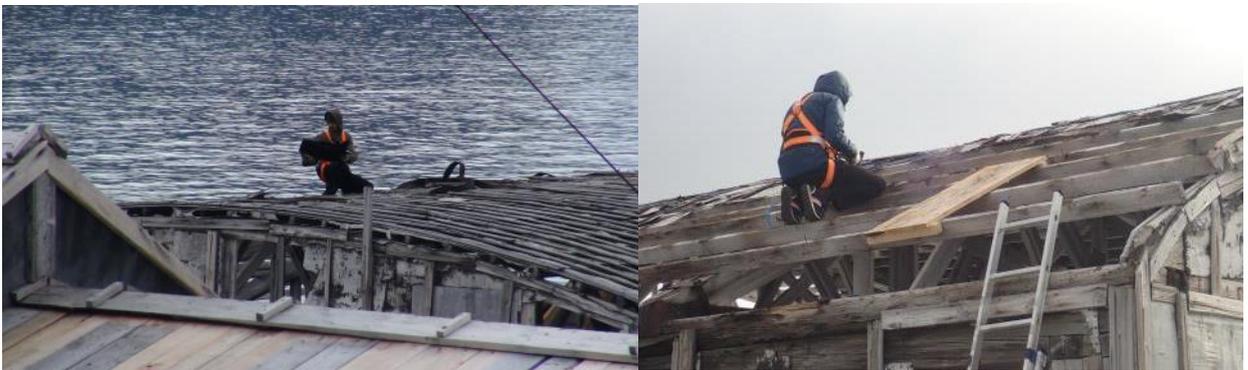
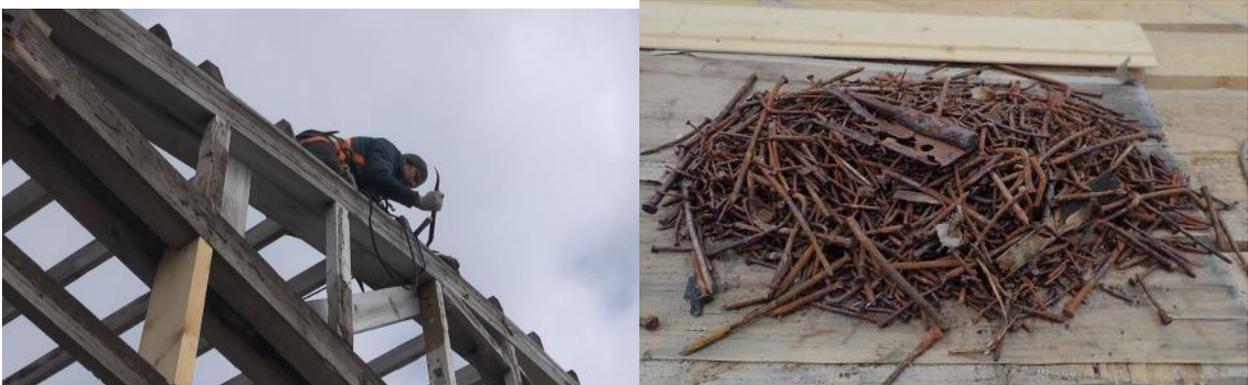
Figure 15. Stripping of the hangar from rusty nails.

At the same time, work began on removing the remnants of the old hangar plywood, the clamping rails and the numerous nails with which they were nailed. The plywood was removed from the roof of the hangar and walls.

There were a lot of nails, around them foci of rotting wood formed. When they were pulled out, the hat was often broken off, after which it was very difficult to remove them.

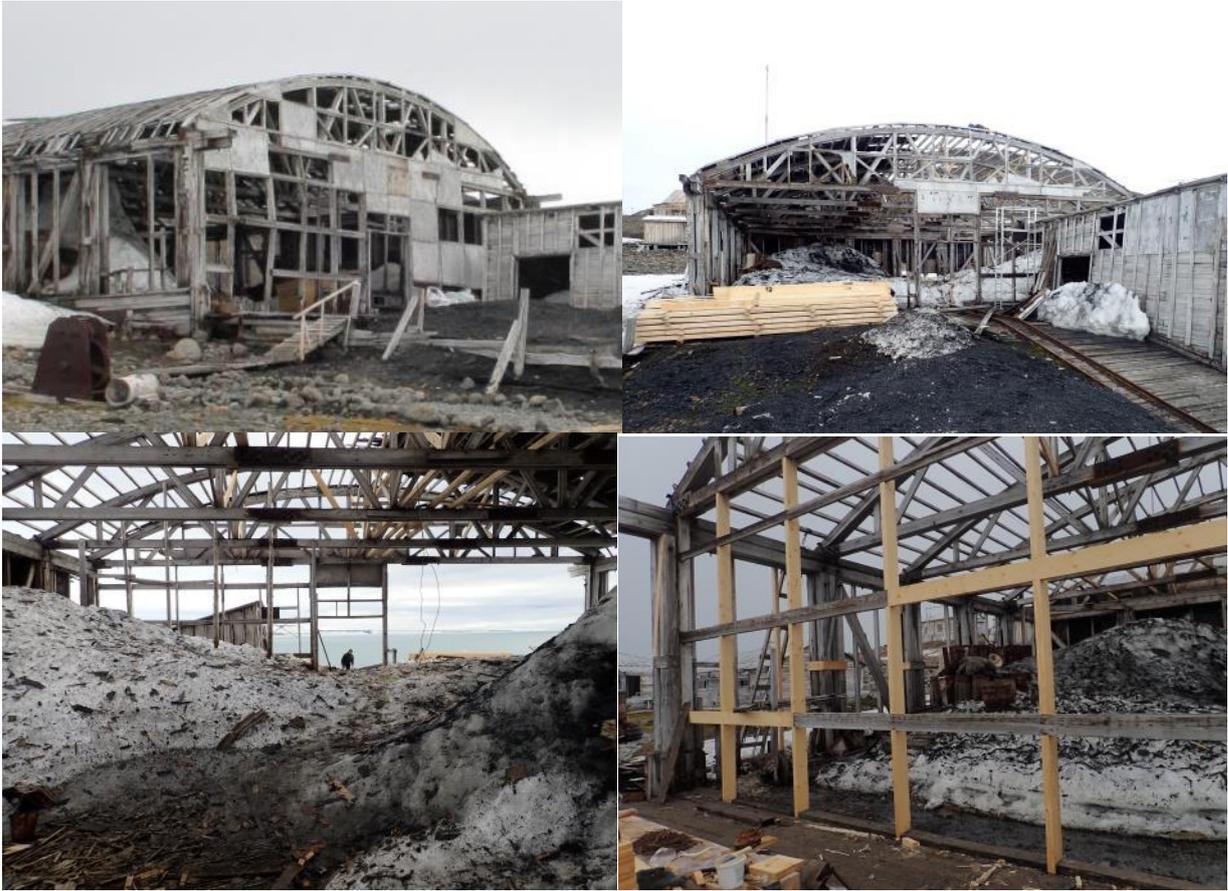
Figure 16. Repair crates

The crate of the main facade of the hangar was repaired. The cladding was in an emergency condition, a number of wooden parts rotted and began to break out. The entire left part of the crate was dismantled, the decaying racks and crossbars replaced by new ones. Then the crate was re-installed.

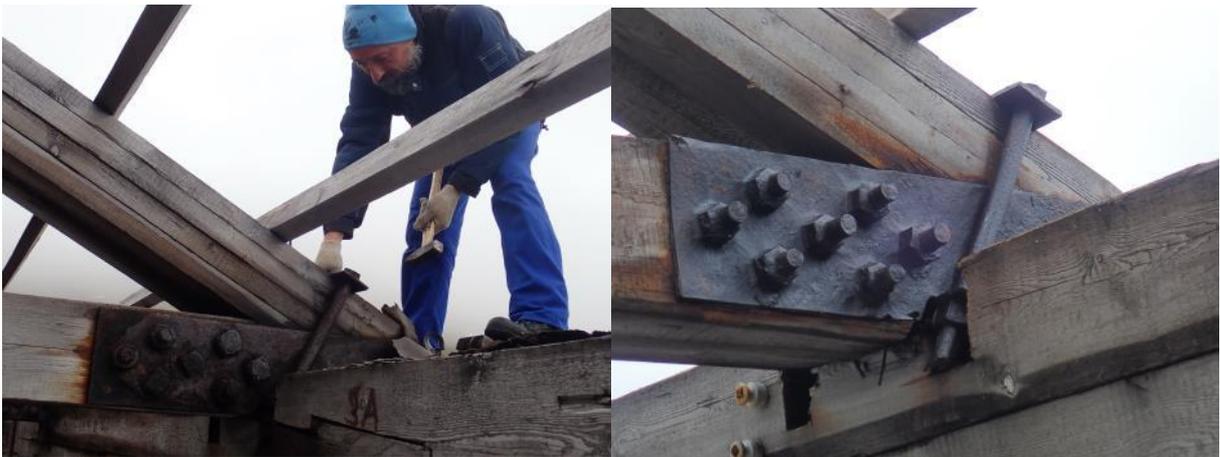
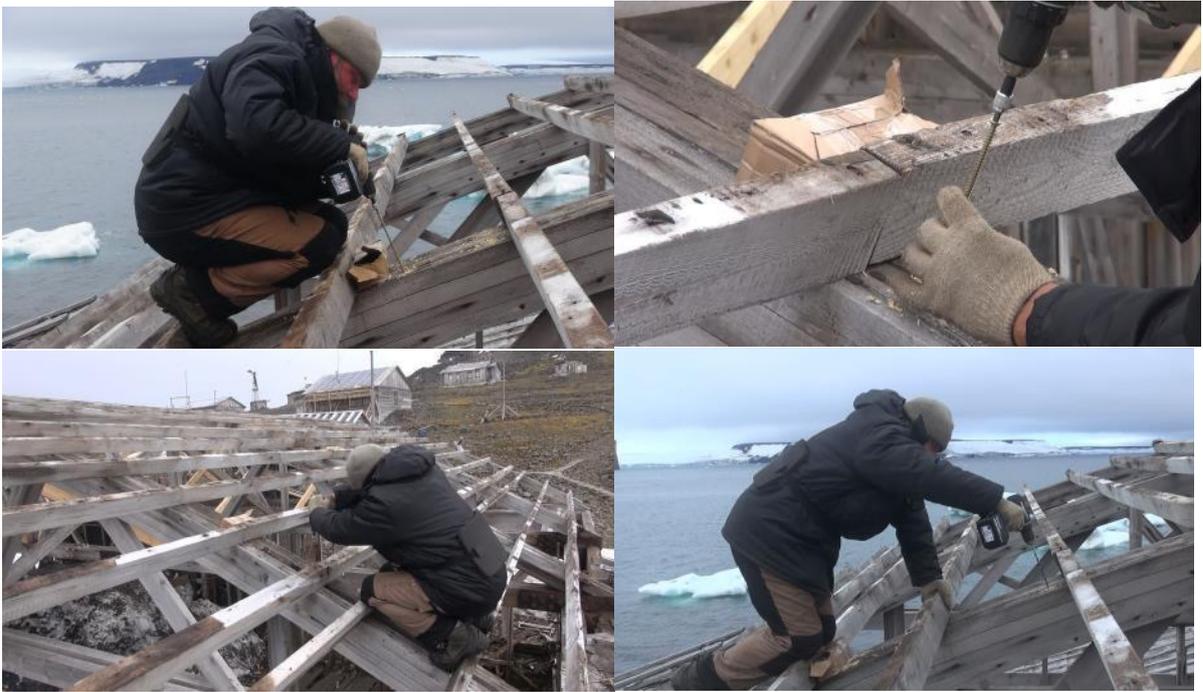
Figure 17. Drilling and cranking of roof trusses with self-tapping screws

For the second week of our stay, we began to clean the metal parts of the hangar farms from the shale rust. They beat rust with a hammer and a chisel. At the end of the procedure, they were coated with a preservative-phosphometh.

The upper arcuate belts of the trusses of the overlap were reinforced with stainless steel nails with a pitch of approximately 25 cm.

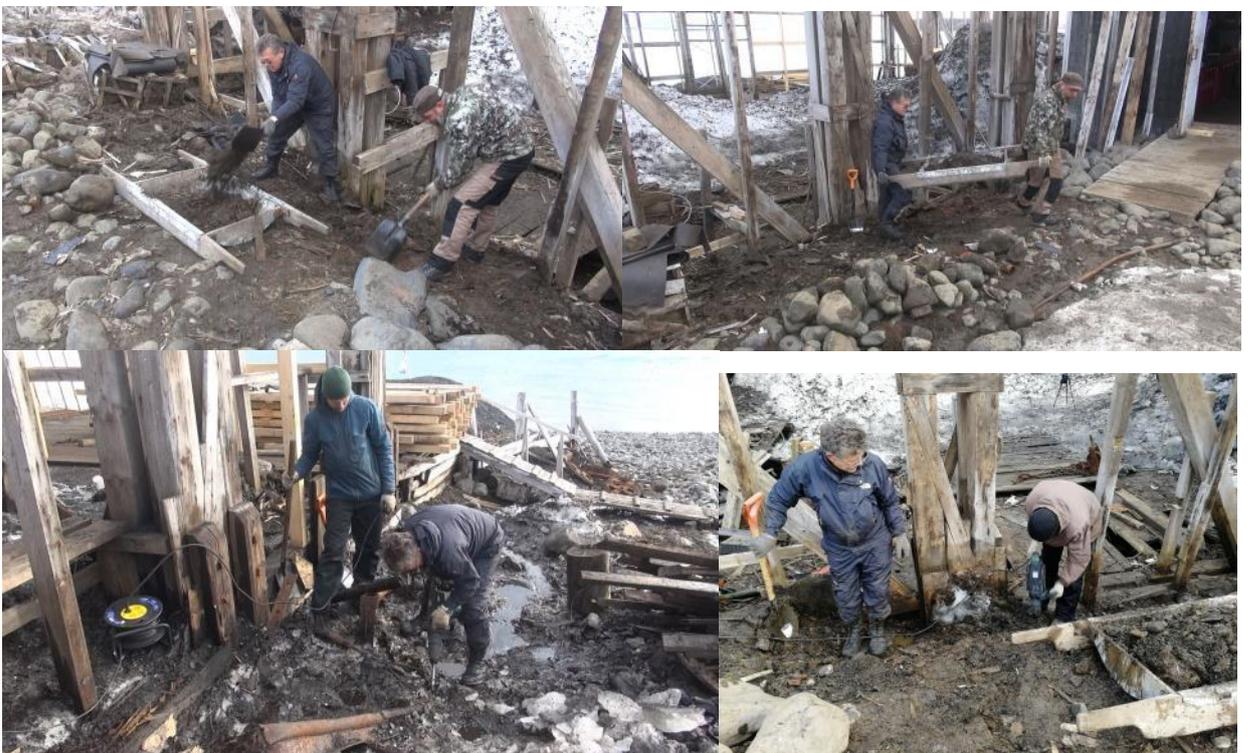
Figure 18. Cleaning the bottom of the hangar

When the active thawing of snow and ice (the end of July) followed, after completion of the work to replace the damaged or missing parts, we began cleaning the hangar facades in order to reach the lower strapping of the structure. Clearing was extremely hard work.

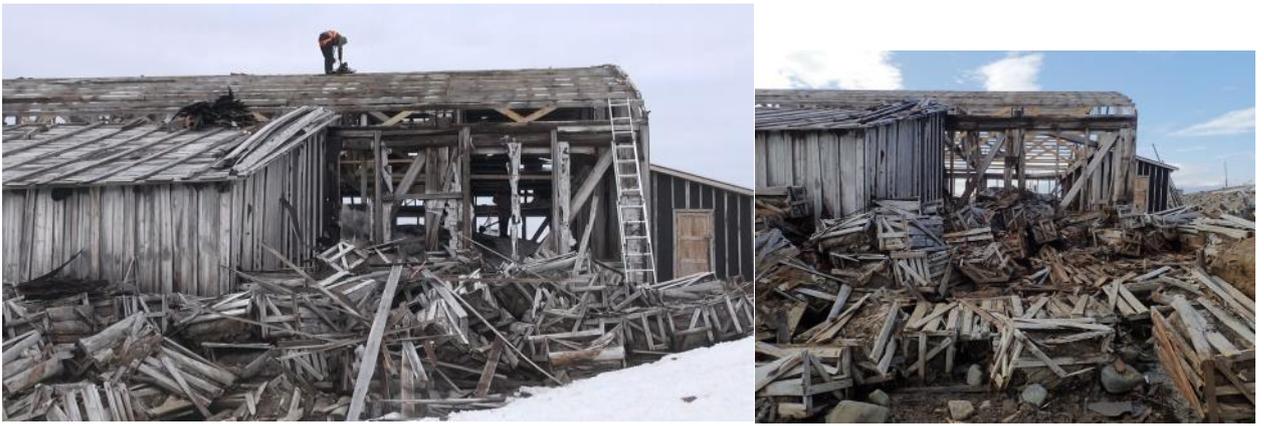
Figure 19. Old insulation near the eastern facade of the hangar

Close to the eastern facade poured a mountain of old insulation in rotten boxes-packages. We managed to remove a few rows of boxes, below the boxes all frosted into the ice.

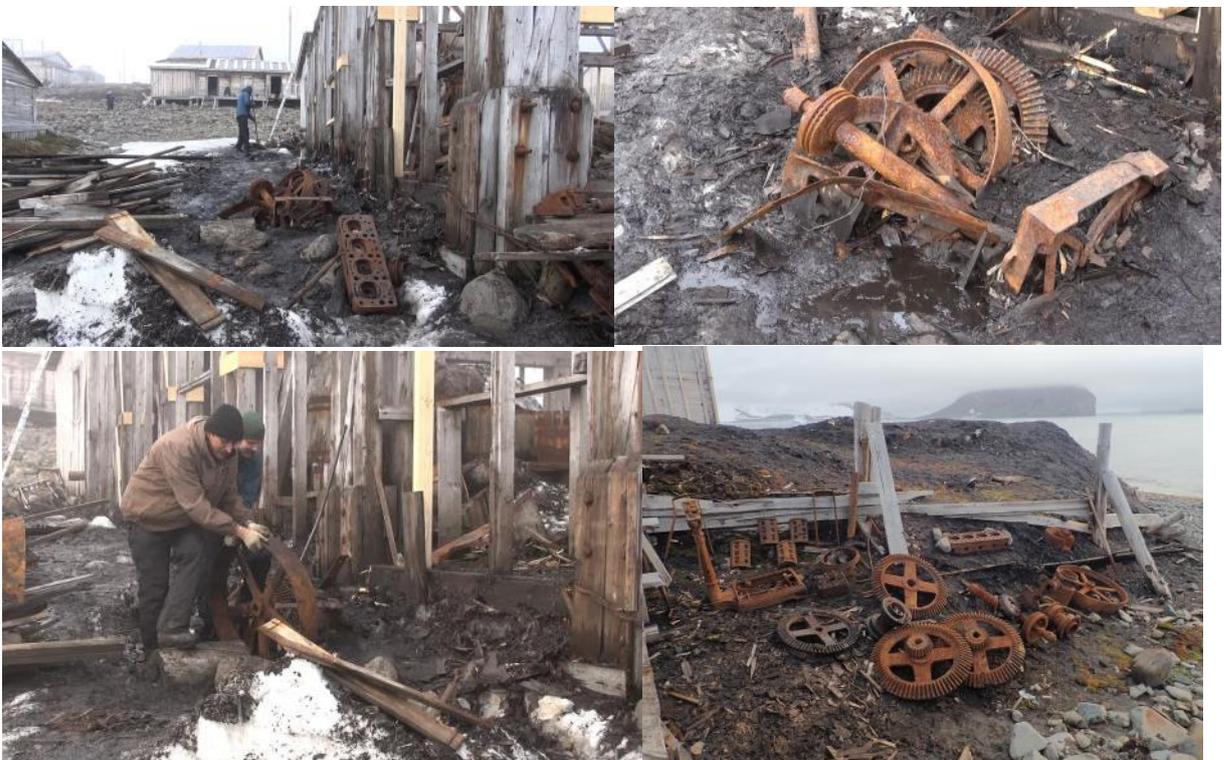
Figure 20. The dismantling of metal details at the western facade of the hangar

During the clearing of the western facade, a number of large gears with a diameter of up to 0.5 m from the windmill, old scales, fragments of weathercocks and various mechanisms were extracted (in the past, in 2017, all this lay almost openly, without snow and ice).

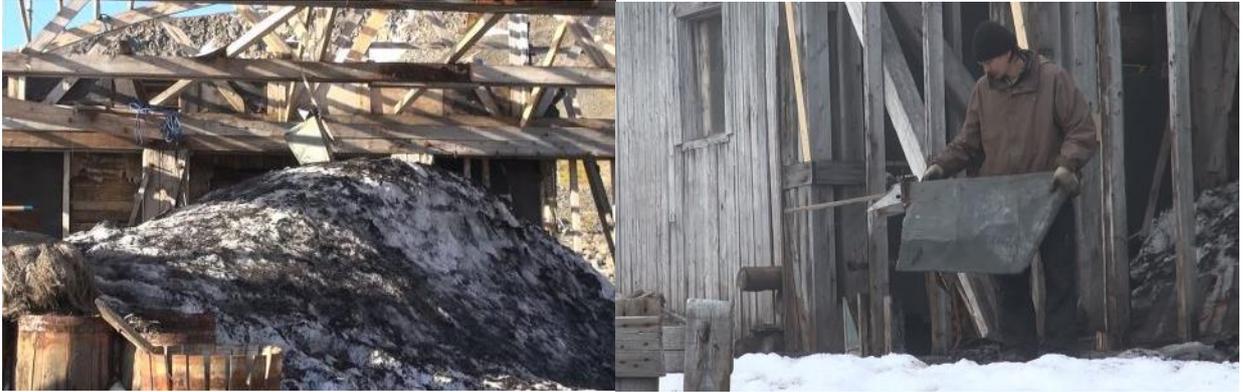
Figure 21. Fragment of the wing of the aircraft

From the glacier on the left stuck out a fragment of the wing of the plane. During our work he thawed to a height of 70 cm and fell out of the glacier.

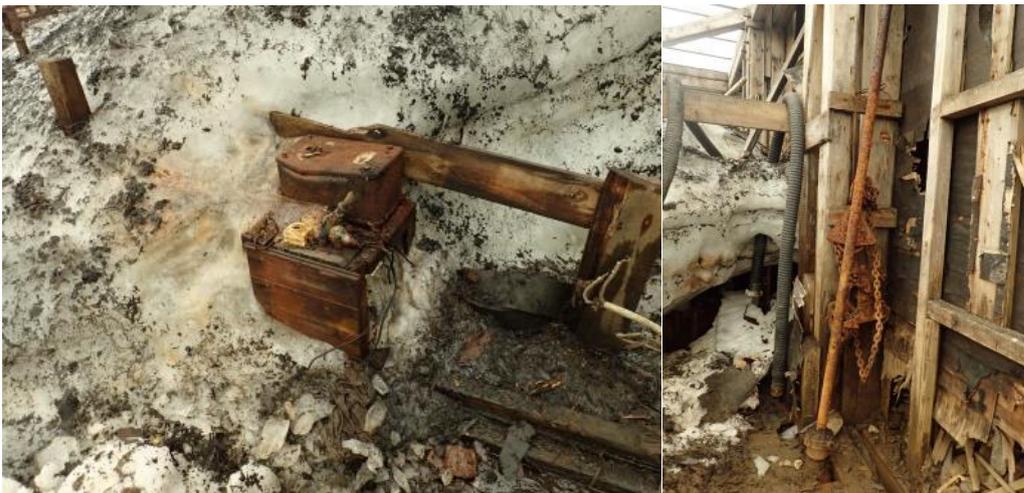
Figure 22. Electric winch on the left, hoses on the right

In the same glacier thaws winch control system and hoses from the fire pump.

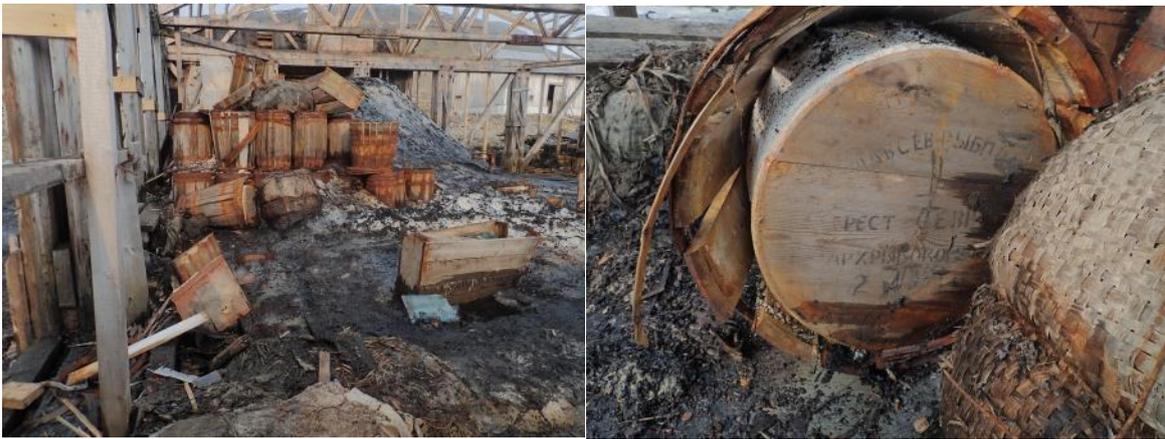
Figure 23. Row of barrels

On the left, along the western facade, several rows of barrels of lime were thrown out (set one on top of the other). Interestingly, some have inscriptions that are of great interest.

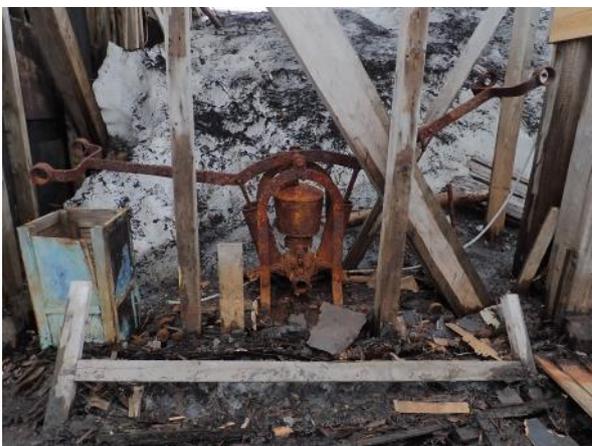
Figure 24. Old Fire pump

Thaw various exhibits, in particular, the fire pump thawed.

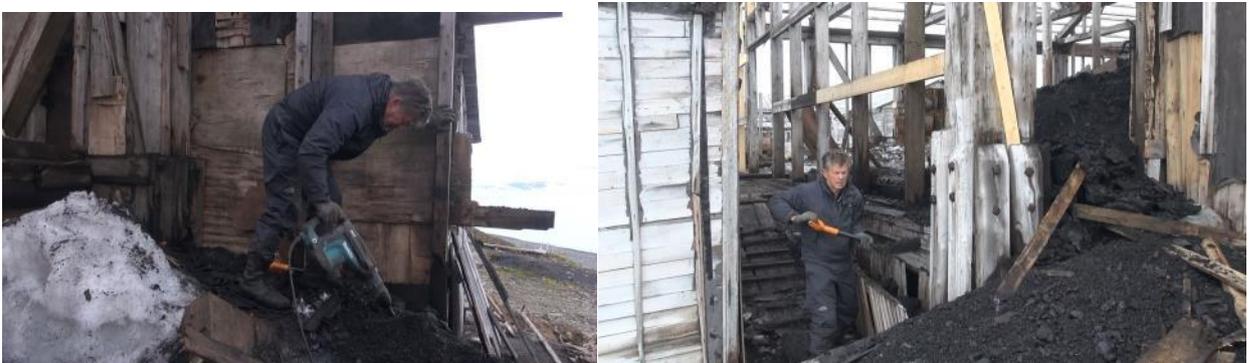
Figure 25. Breakdown of coal in the right near corner of the hangar

The entire right corner of the hangar at a height of 2-2.5 m is filled with frozen coal, which began to beat out a jackhammer.

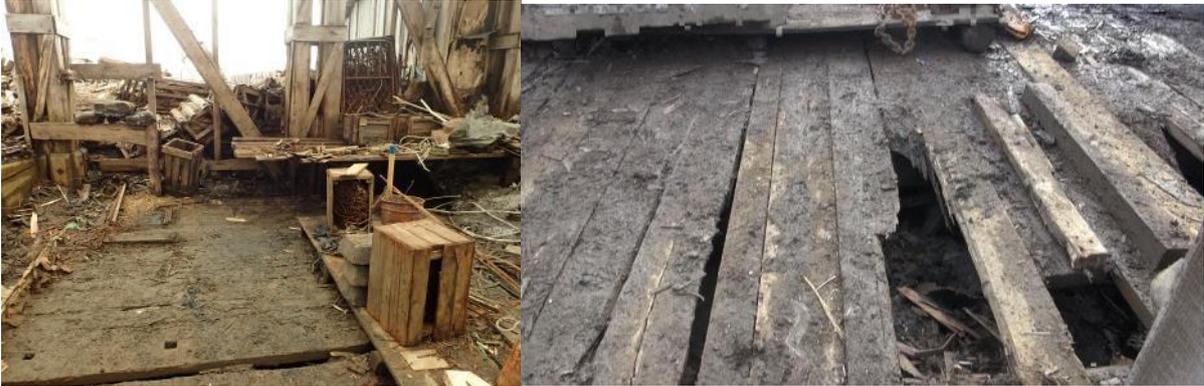
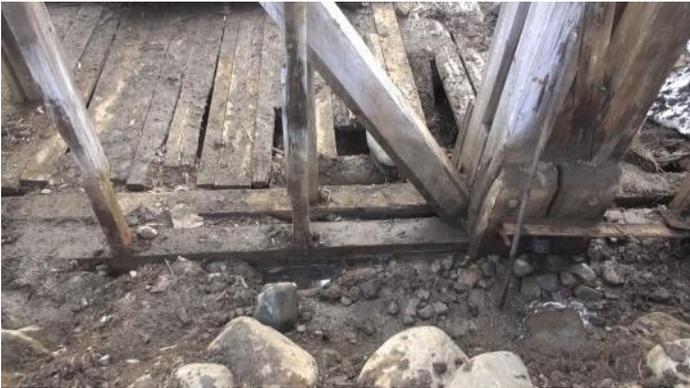
Figure 26. The floorboards in the far right corner of the hangar and the lower strapping

The floor was thawed and cleared of ice and debris on an area of about 4x4 m in the right far corner. At this point a stream flows into the hangar. In the period of active melting under the floorboards, water rumbled, and it lingered there in the form of a large puddle. The floorboards in this end are in poor

condition, rotten and broken. At the same end, because of the creek, a mixture of clay and manure was dripped into the hangar, which mixed with various construction debris, in particular, with shingles all over the floor for the plastering of walls in houses. There were also fragments of a completely rotted, crumbling aircraft wing. In some places, the remnants of the wing retained a red color. In the same corner there is a table on which lie several wooden boxes with frozen and rusty nails. The most valuable in these boxes are the inscriptions on them "Silent Bay", "Observatory", "GUSMP", etc. Collected in the hangar finds are stored in the building of aerology.

2) Next year, after clearing the floors, the volumes for replacing the floorboards will be determined. Opening the floors and strapping along the facades will show the existing problems with the foundation, on the basis of which decisions will also be made.

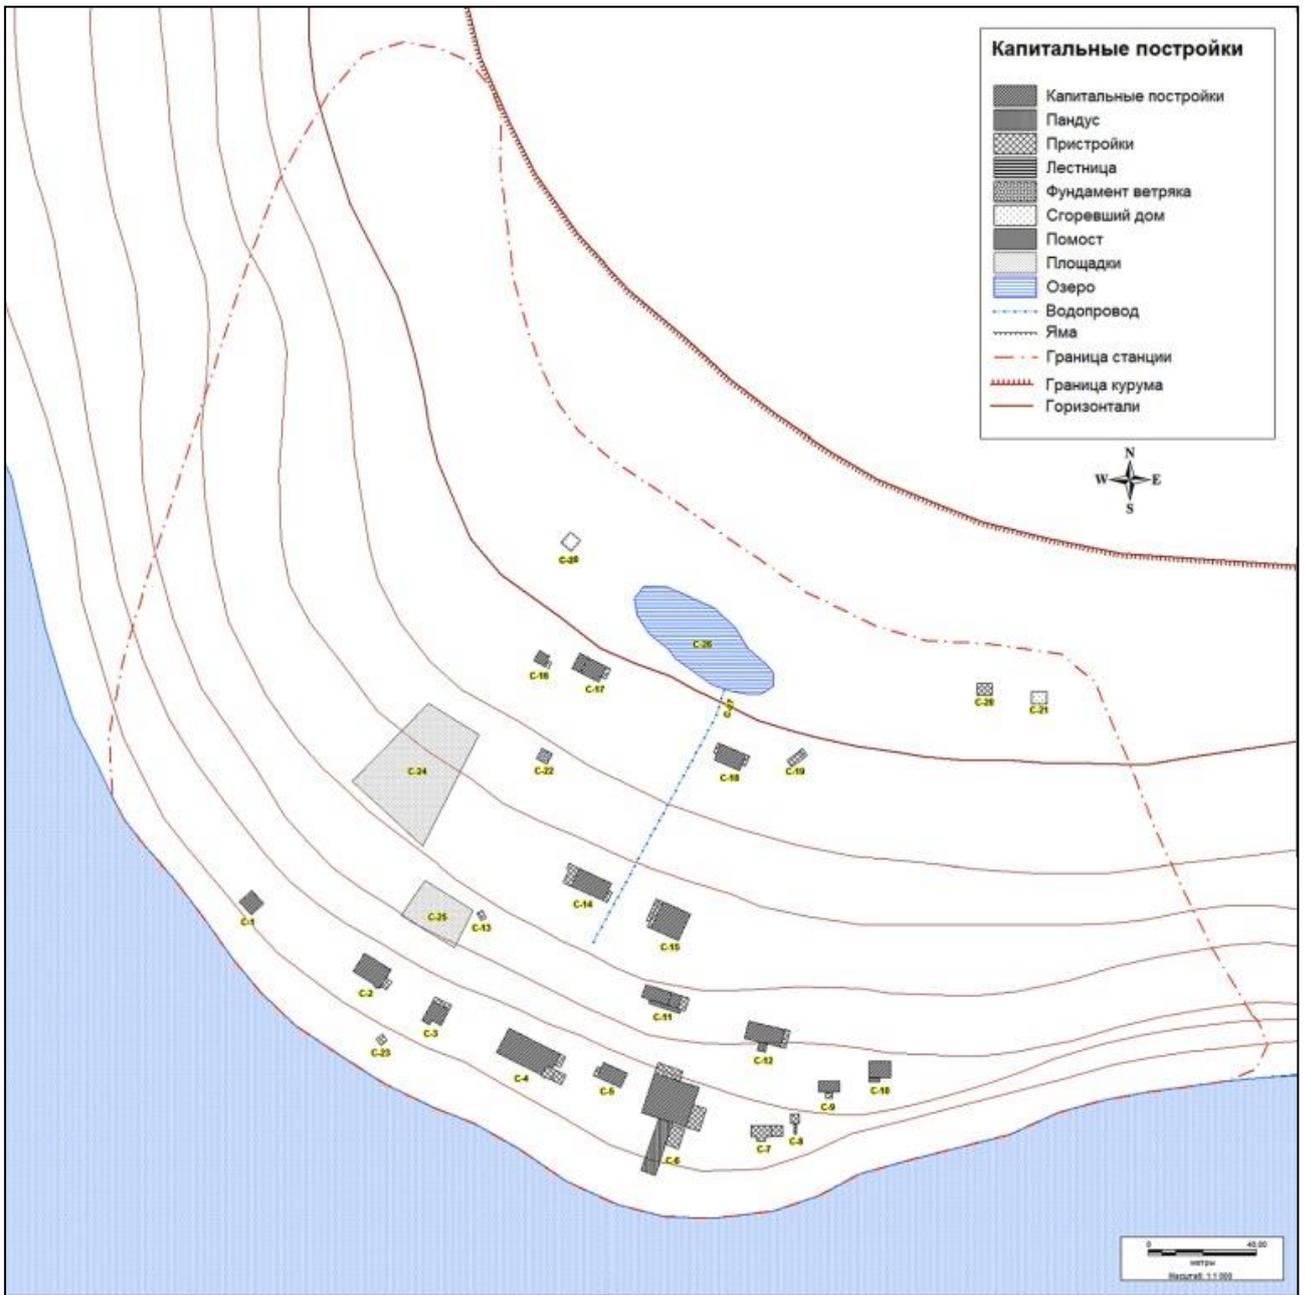
Figure 33. Scheme of the capital structures of the Polar Station of the Bay Tikhaya according to the report of NP "Russian Arctic" for 2011

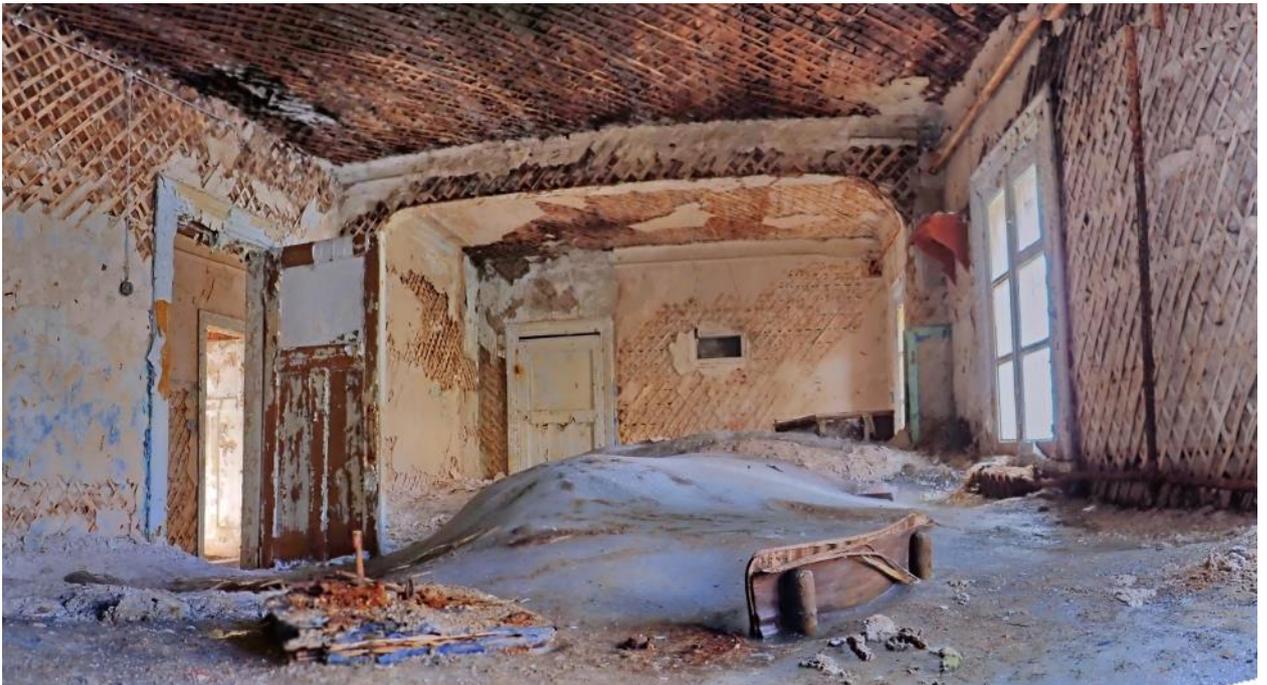
Figure 35. The glacier in the house number 1

This is the main house of the station (house number 1). The capital structure, the roof and the walls are in good condition. Inside, the house is half-full of glaciers, in the middle of the house the glacier was removed as early as the 90s. A clear concept for using the house at the park is not. In the future, they plan to remove the glacier from the house and make there either a "polar museum" or a guest house for staff and guests, or both. In any case, the development of design estimates and restoration work is required. Inside the house is a lime finish with decor elements. It is necessary to understand how and in what materials it is to be restored. Now the rooms, clogged with a glacier in themselves look extremely curious and unusual - ice-staked chairs, tables, heating batteries ... A real ice kingdom, a frozen time. Perhaps in this form it is necessary to museum the house? This picture resembles the kind of room of happiness from the movie Tarkovsky "Stalker". In order to study the process with ice in the house, I was given ice level marks - wrapped with screws with a red tape on them wound on which the date of marking was written by the marker.
